Manhole Inspection Summary

Manhole # S11QQ1013MH

Insp Date: **5/13/09 3:29 PM**

Location Address: **4921 GARRISON AVE**

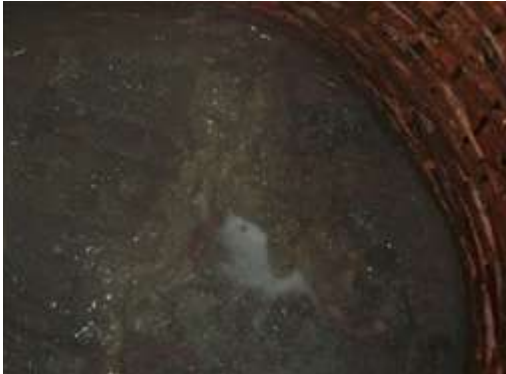
Defect 2

Surcharge ☒ **Evidence Of Surcharge** Depth: **4.** (ft.) ☒ **Active Surcharge Present**

SURCHARGE

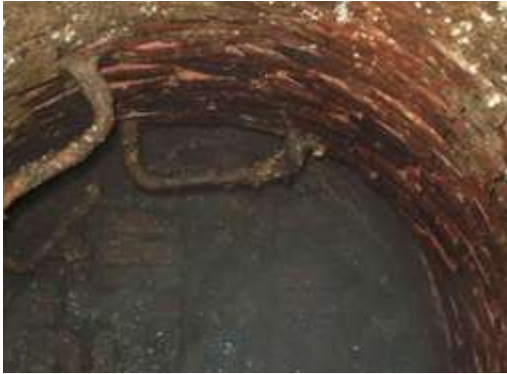
Defect 1

CORRODED STEPS

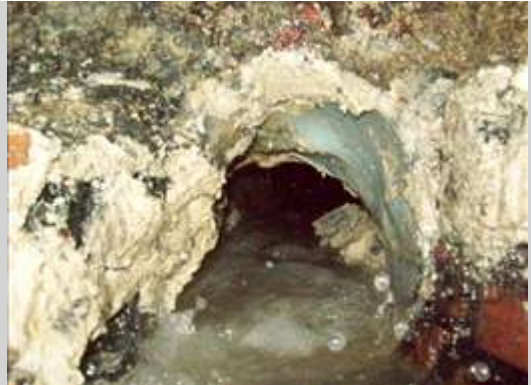
12 O'Clock Outflow

CORRODED STEPS

Pipe Height: (in.) Direct
Pipe Material: **Clay** ☐ Pipe Lined
Invert Depth: **9.58** (ft.) Flow Characteristics: **Fast**
Deposits: ☐ None ☐ Mud ☐ Sludge ☐ Debris ☒ Grease
Silt Depth: **3** (in.) Deposits Extent: **Medium**
Infiltration: **None** Pipe Seal Cond: **Sound**

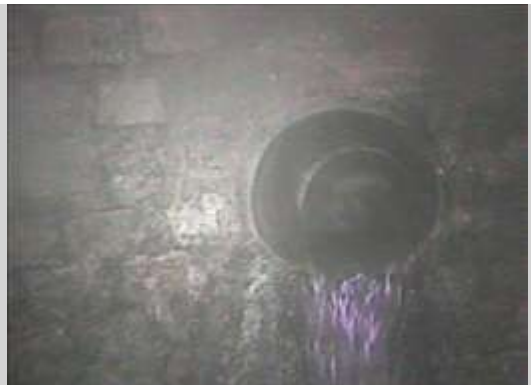
3 O'Clock Inflow

CORRODED STEPS

Pipe Height: (in.) Direct
Pipe Material: **Clay** ☐ Pipe Lined
Invert Depth: **7.32** (ft.) Flow Characteristics: **Fast**
Deposits: ☒ None ☐ Mud ☐ Sludge ☐ Debris ☐ Grease
Silt Depth: (in.) Deposits Extent:
Infiltration: **None** Pipe Seal Cond: **Sound**

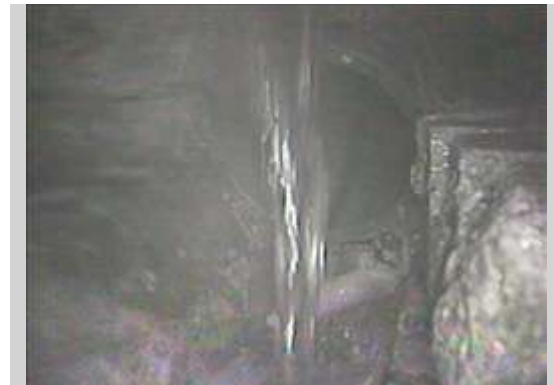
Drop In @ 3 O'Clock

CORRODED STEPS

Drop: **Inside** **Direct**
Angled: Reading: (ft.)
Inv Depth: **9.36** (ft.)

Drop Condition: **Open**

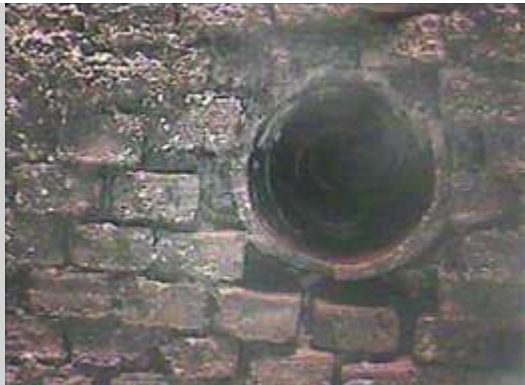
9 O'Clock Inflow

Deposits: ☐ None ☐ Mud ☐ Sludge ☐ Debris ☒ Grease

Silt Depth: **4** (in.) Deposits Extent: **Medium**

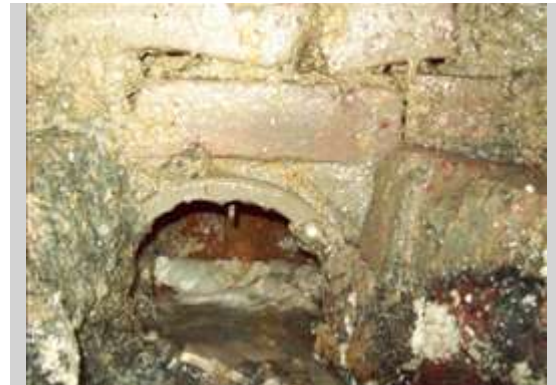
Drop In @ 9 O'Clock

CORRODED STEPS

Drop: **Inside** **Direct**

Drop Condition: **Open**
